Inspection Report

Tracking ID: PC2006-068

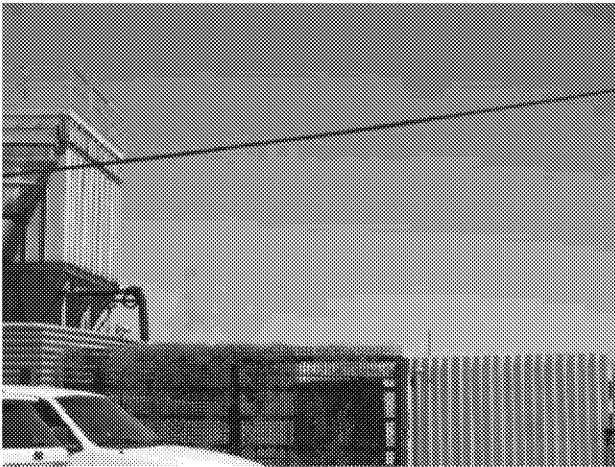
Date: June 17, 2020
Tracking #: PC2006-068

Pima County Department of Environmental Quality (PDEQ) inspectors conducted off-site surveillance observations of Tucson Iron & Metal (TI&M) in the public easement located near the intersection of E. Kentucky St. and S. Belvedere Ave. The public easement provided an off-site observation position for viewing TI&M's incinerator and baghouse. During previous inspections, PDEQ had observed sustained plumes of black smoke emitting from TI&M's Other Solid Waste Incinerator (OSWI).
